Concrete Body Waterproofing

The intended silicate-based surface penetrant and silicate-based waterproofing material are clear watery solution of silicate as main component and is the material to enhance water-tightness by impregnating into concrete to fill concrete fine gaps with C-S-H crystal.

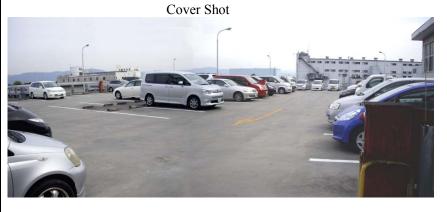
Crack Investigation Map

Ciwin in Vonganen, recamb	Measuring QTY (m)	Target Area	Crack QTY per Area (m/m²)	Self-Healed Rate (B/A)
A) Total QTY, Cracks (m)	174m	1,575m ²	0.11m/m^2	
B) QTY of Self-Healed Cracks among Cracks (m)	174m	1,575m ²	<u> </u>	100%

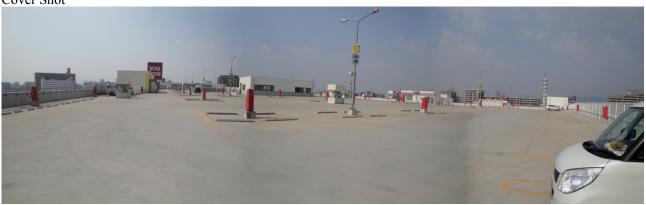
Crack Investigation Map

,	Measuring QTY (m)	Target Area	Crack QTY per Area (m/m²)	Self-Healed Rate (B/A)
A) Total QTY, Cracks (m)	890m	20,528m ²	$0.043 \mathrm{m/m^2}$	
B) QTY of Self-Healed Cracks among Cracks (m)	765m	20,528m ²		86%

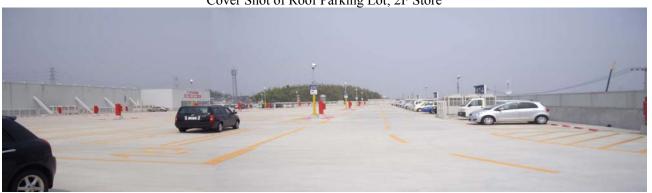
Cover Shot of Roof Parking Lot; 2F Store

Detailed Photo, Joint Section

Crack investigation, results	Measuring QTY (m)	Target Area	Crack QTY per Area (m/m²)	Self-Healed Rate (B/A)
A) Total QTY, Cracks (m)	60m	13,233m ²	0.004m/m^2	
B) QTY of Self-Healed Cracks among Cracks (m)	60m	13,233m ²		100%
